BPI Inspection Report

Test OUT: John Customer

Date/Time:	2015-06-18 09:00:23
Street Address:	12345 Example St Los Angeles, CA 90011
Square Footage:	3300
Stories:	2
Average Ceiling Height:	10
Year Built:	1988
Garage:	Attached
Outside Temperature:	63
Number of Occupants:	3
Number of CO Detectors:	3
Number of Smoke Detectors:	8

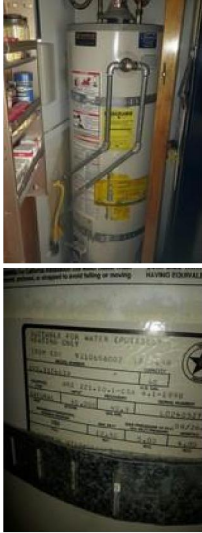
Water Heater #1
Make: Kenmore
Model: 153.337463
Location: Attached Garage
Type: Natural Draft
Fuel: Natural Gas
Gallons: 40
BTUs: 40000

Water Heater(s):	Non metal stand - recommend drip tray. Model number obstructed by the earthquake strap...
Furnace(s):	...
Air Conditioner(s):	<p>Attached photos illustrates unsealed intake plenum ...</p>

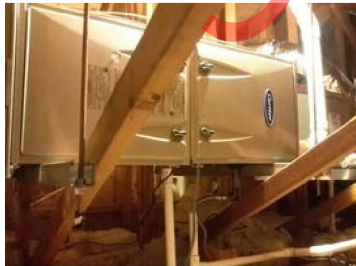
Furnace #1
Make: Carrier
Model: 59SP2A060E14
Location: Attic
Type: Sealed Combustion FAU
Fuel: Natural Gas
BTUs: 56000

<p><u>Furnace(s) [1-2-3]:</u> Flue pipe terminates w/in 4 ft of gable vent - Check mfg specs for proper clearance.</p>

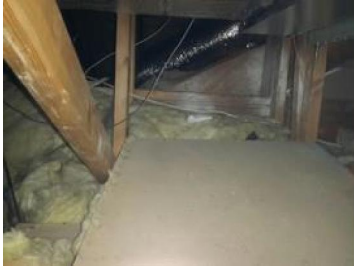
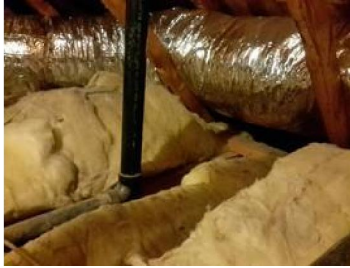
Attic Type:	Vaulted Attic
Insulation Type:	Fiberglass Batts
Insulation Depth (in):	10
Insulation Condition:	Fair
R-Value:	20
Radiant Barrier?	no
Are ducts present?	yes
Duct insulation R-Value:	R-8
Percentage of ducts buried:	0

Attic Notes:	<p>Is there another attic type? no. Open areas of knee wall insulation could be reinstalled for higher R value. Fold-down stairs - Insulation & air sealing will greatly reduce infiltration / exfiltration.</p>
